Example 9 – Structural Collapse

This is a two storey 1920s terrace property. It contains 2 bedrooms and a bathroom to the first floor, and a living room, dining area and kitchen to ground floor. It is constructed of solid brick walls, tiled roof and single glazed windows.

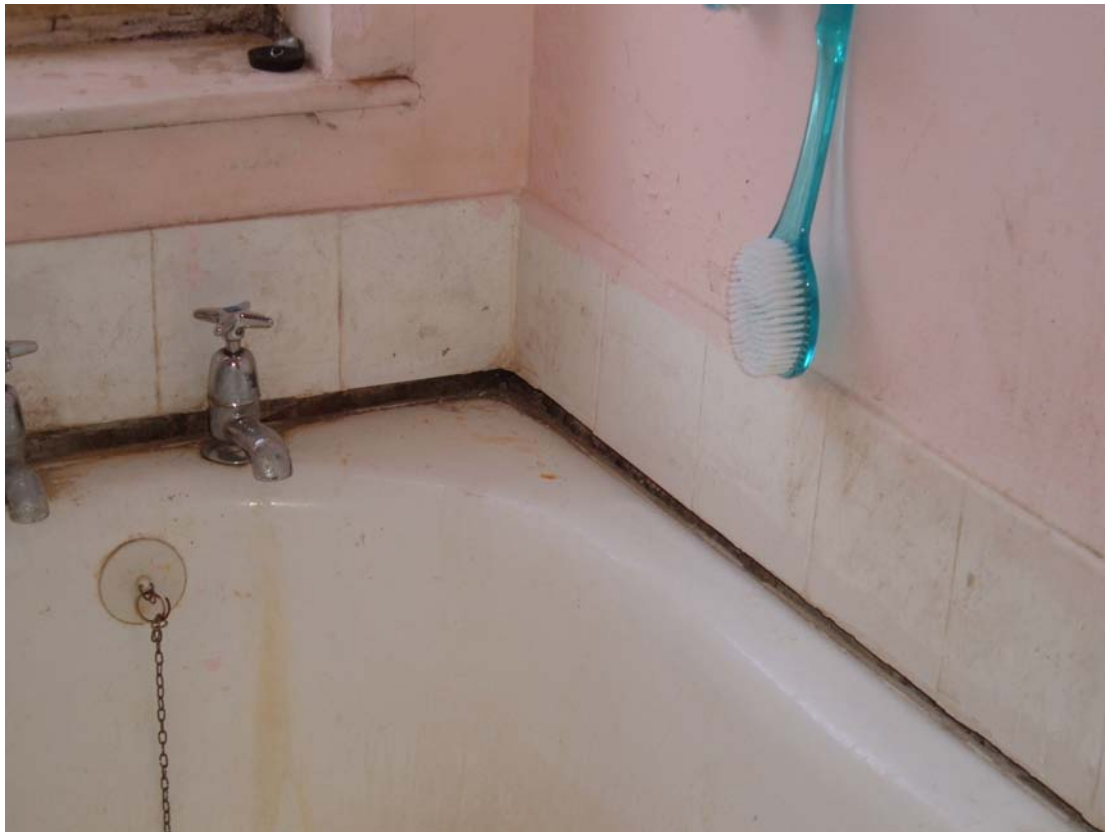
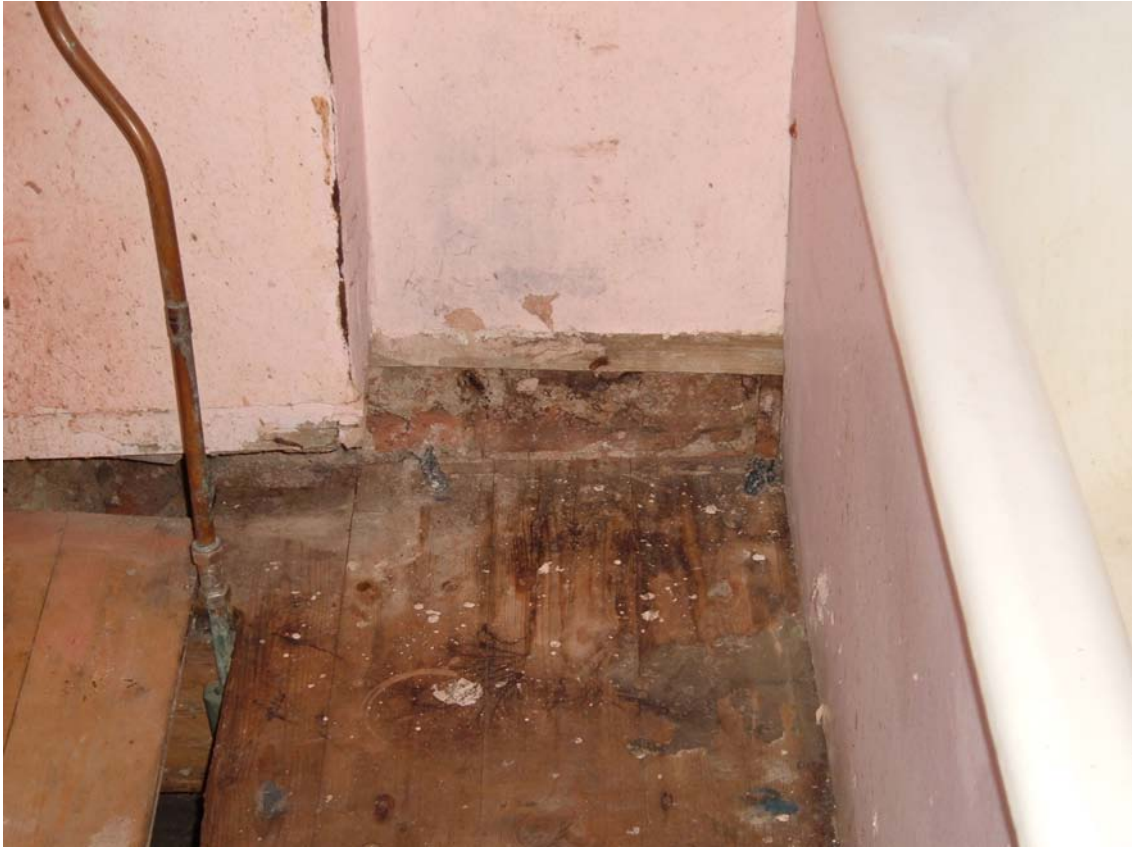
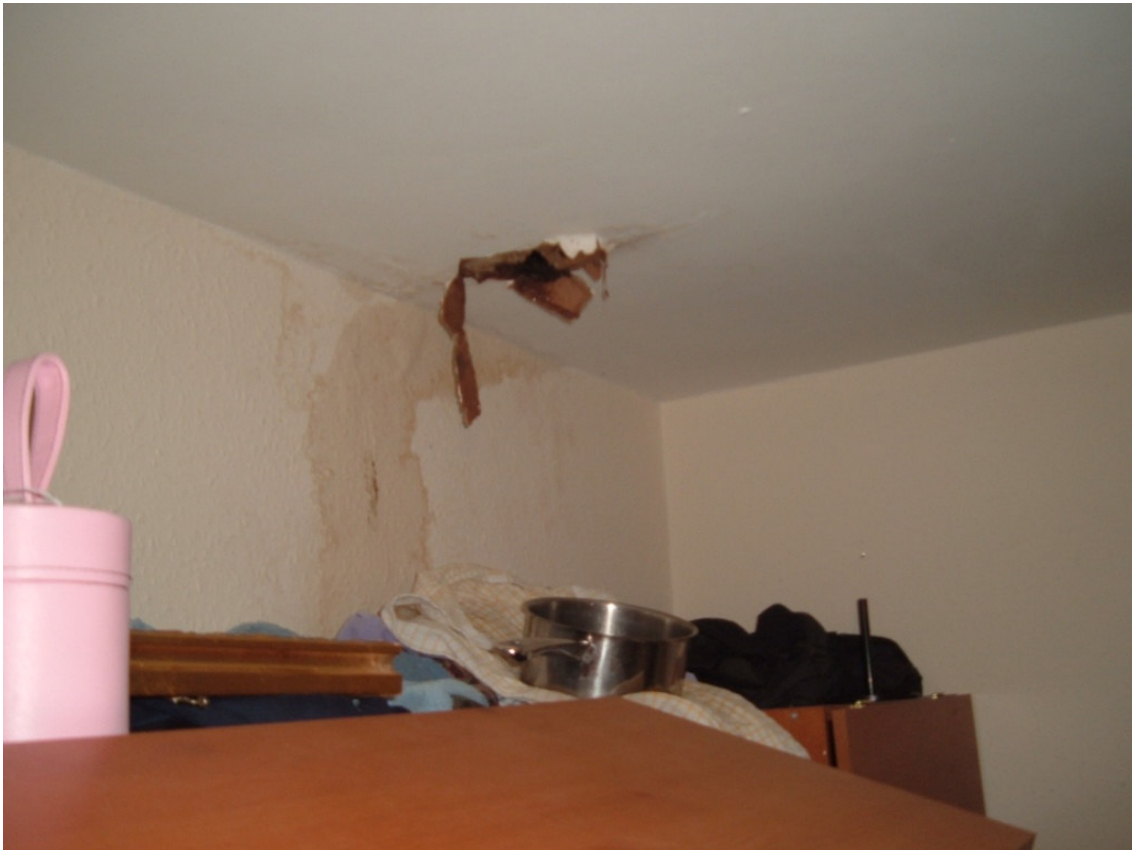
There is a leak to the bath and potentially to waterpipes under bathroom floorboards. This has resulted in damage to bathroom floorboards and dining room ceiling. There is also evidence of rot to the ceiling joists, and the bath appears to have sunken by approximately 1.5 centimetres.

**Evidence of floor movement
 Rot to floorboards and ceiling joists
 Evidence of bath movement**

Potential Impact of a bath filled with water with a person in it will be great.

Score (if calculated) **984**

The group decided that they would probably address the issue with the landlord in an informal manner in order to resolve the issue.
