Example 10 – Falls Associated with Stairs and Steps

HHSRS V2 SCORING SHEET

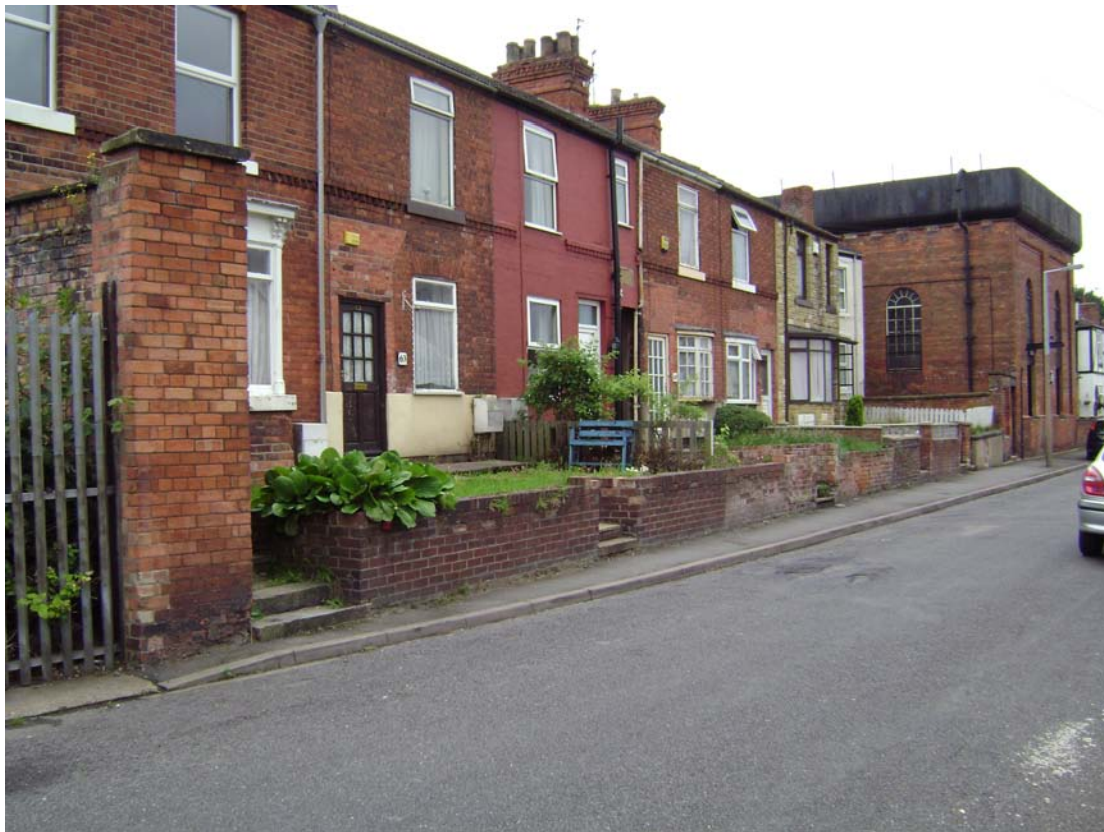
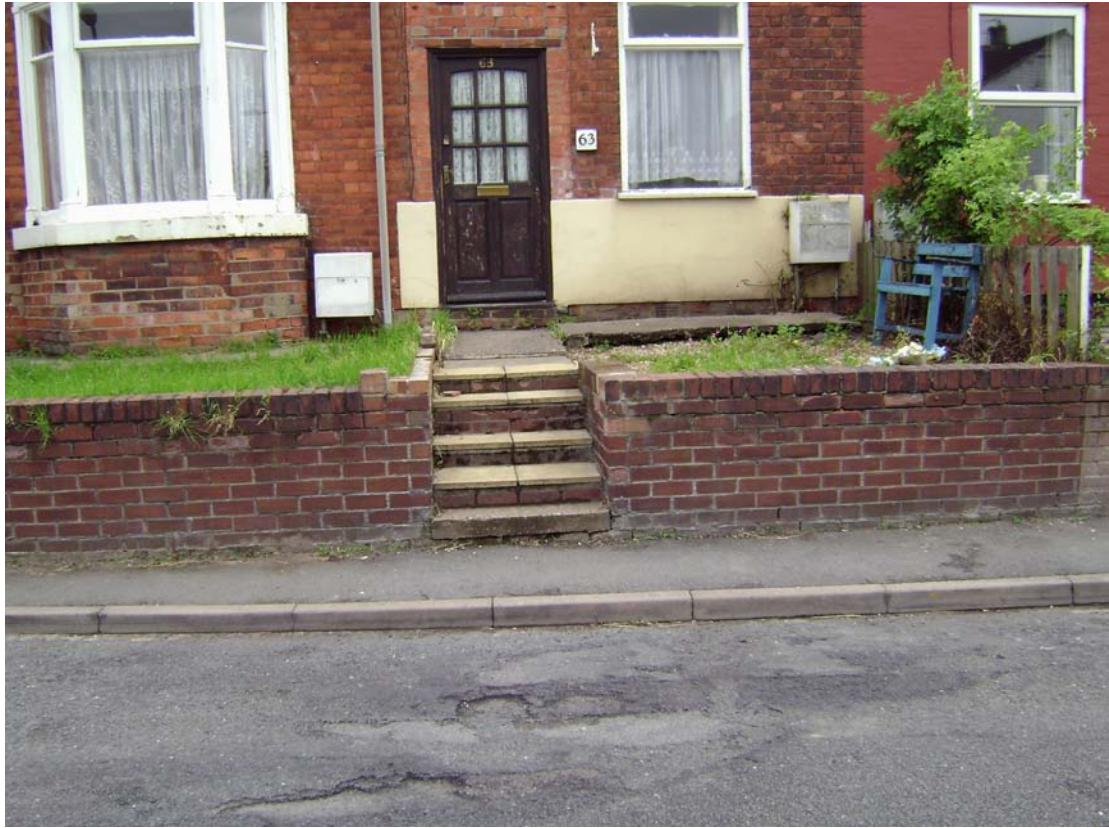
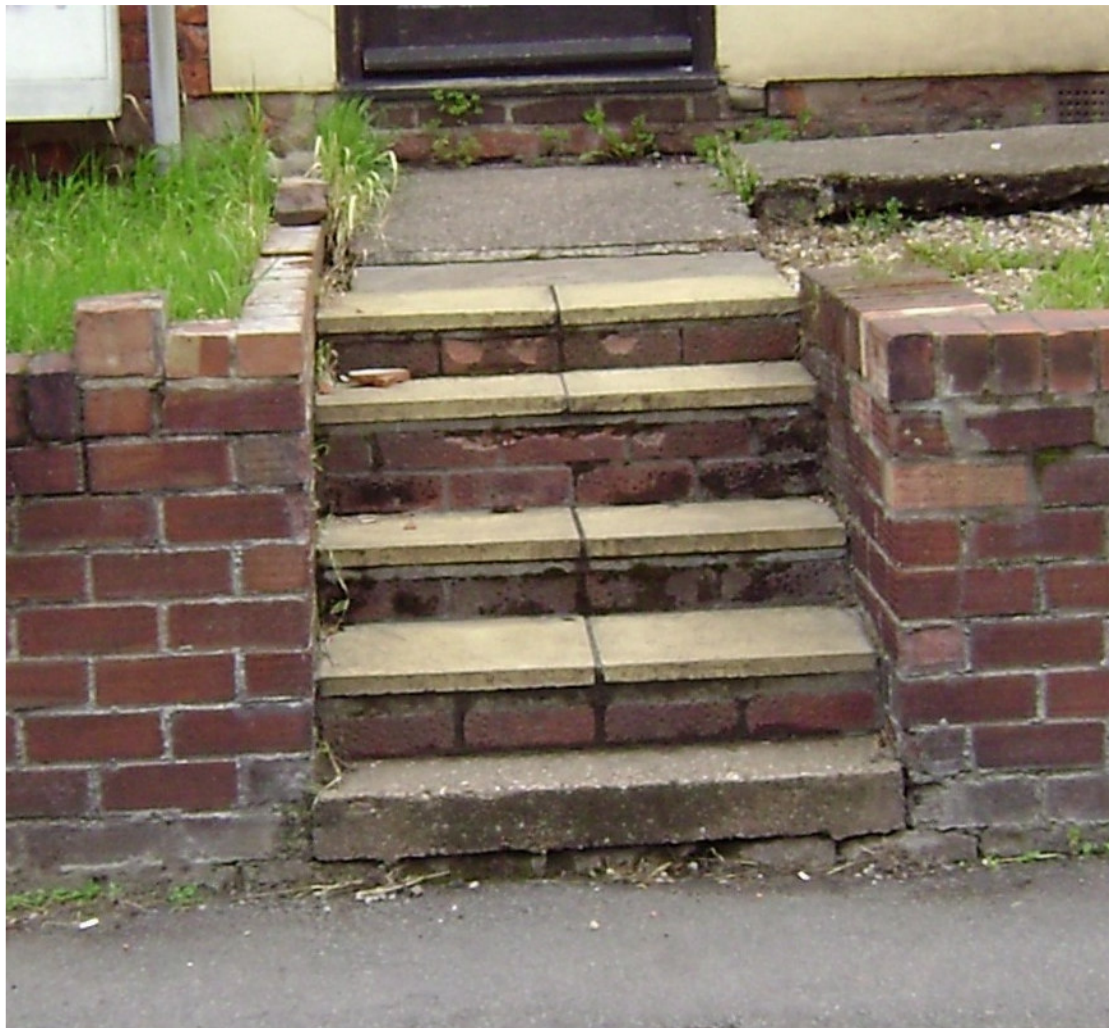
This row of pre-1919 terraced houses is raised above the ground on what was originally the side of a hill. All properties have steps rising up to them and a short concrete path to the front door. None of the properties have a handrail to the steps. This particular property has steps of irregular riser height and tread depth.

The child in the property has already fallen down the steps and gashed his head open; a visitor has fallen up them.

Poorly lit area
No handrails
Uneven risers
Loose slabs

Concrete steps – hard surface to land on
Close proximity to road
External stairs therefore colder weather and elderly more likely to suffer worse harm

The group agreed that they would serve an improvement notice on the property in question, and serve hazard awareness notice on all adjacent properties with similar steps at the front.
