HHSRS Worked Examples from East Midlands Standardisation Working Group 5, September 2006

Example 4 - Falls Associated with Stairs and Steps

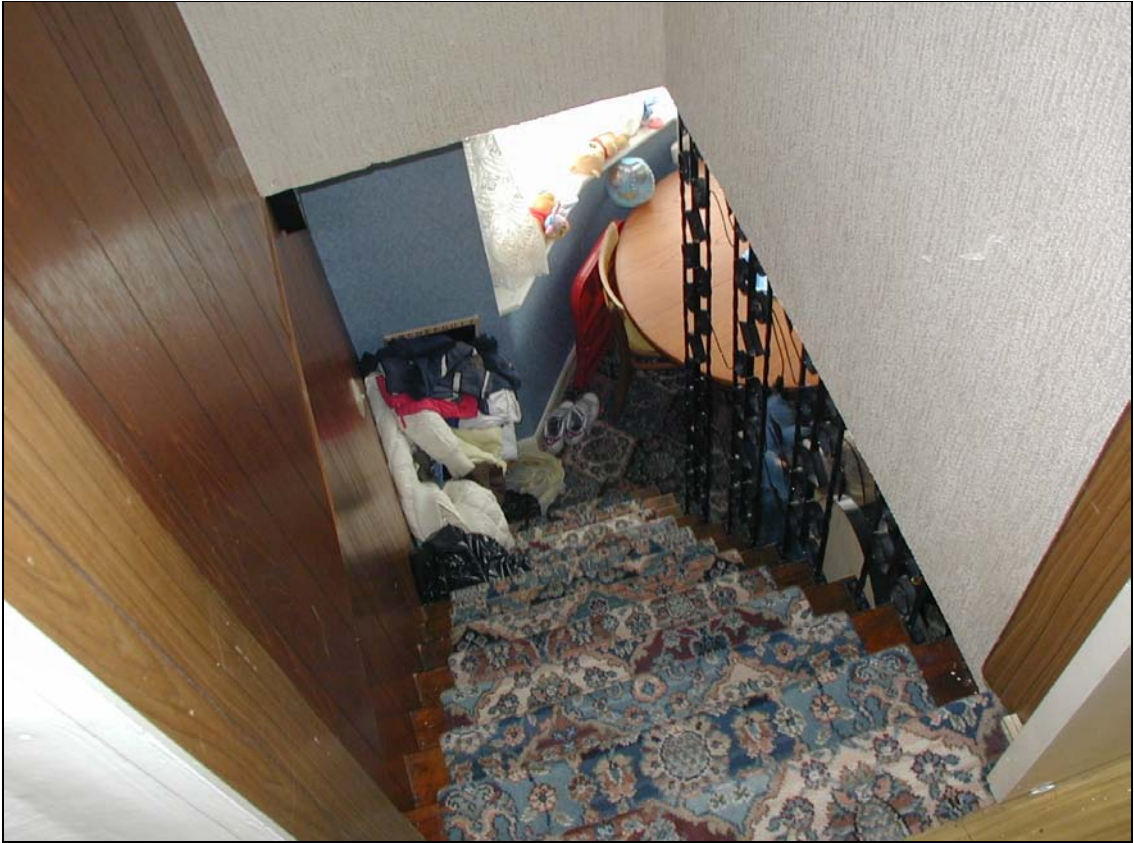
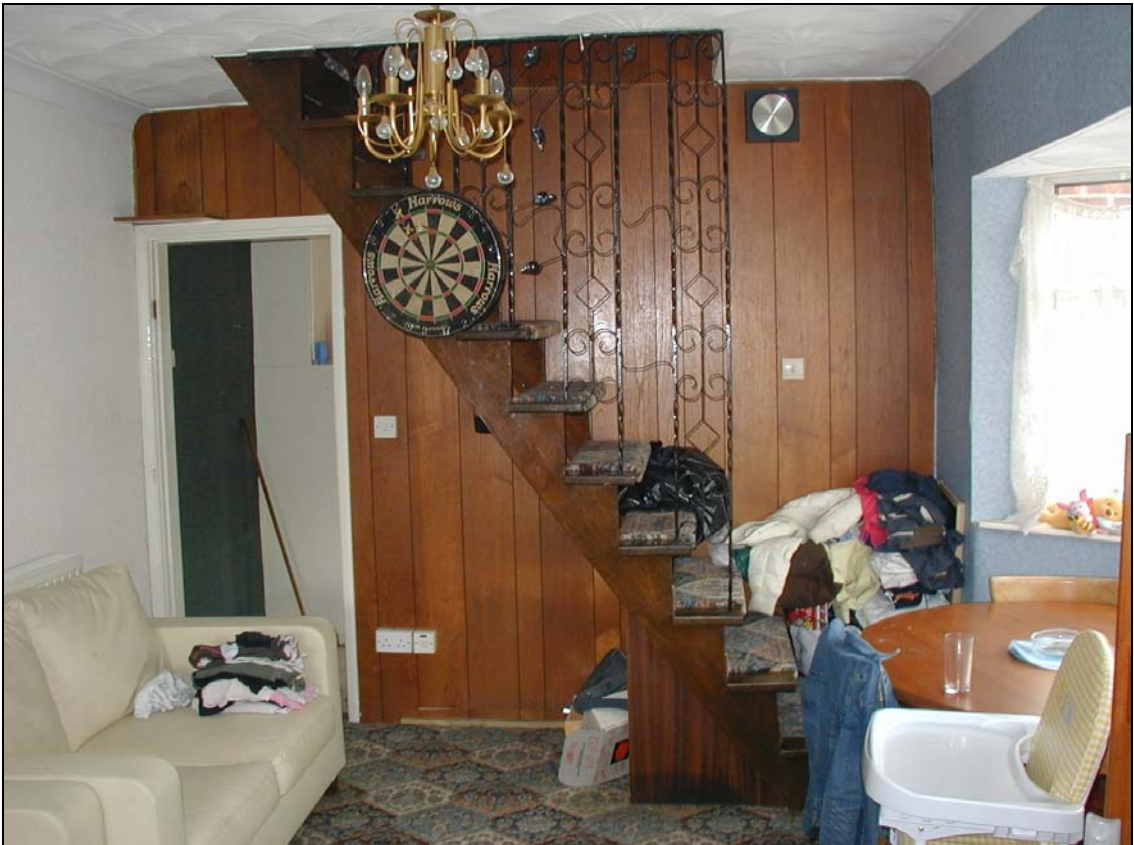
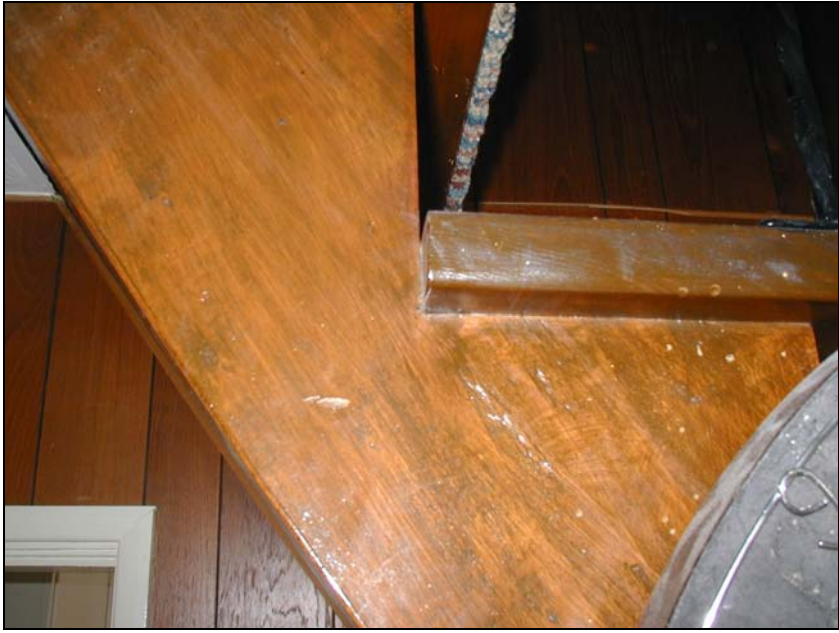
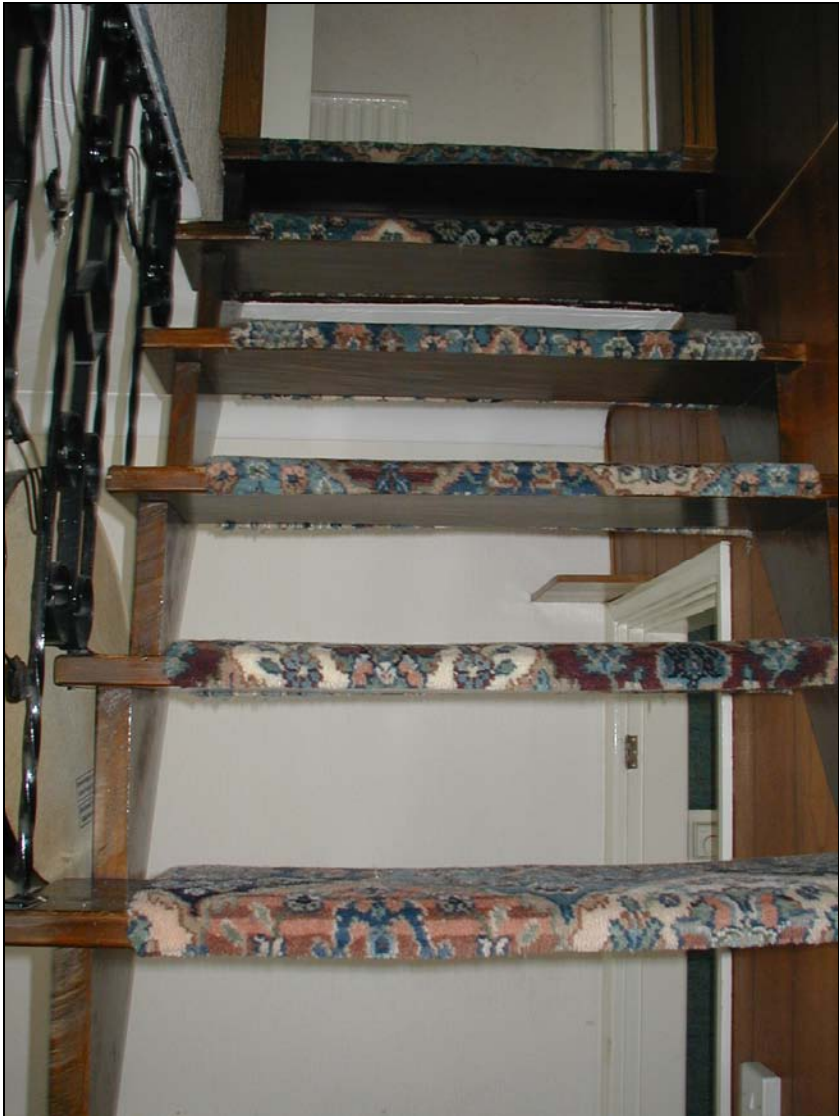
The stair is excessively steep (52°), had inadequate and insecure guarding, no handrails, ill defined treads, excessively large nosings which serve to reduce the area of tread that is available on descent of the stair.

The risers are open and of excessive size such as to permit a child to fall through the gap.

The landing at the foot of the stair is extremely restricted and is subtended 50% by a brick wall and 50% by a bay window containing a table.

The guarding is not adequately secured to the first floor ceiling/floor construction.

The guarding contains within its structure elements upon which a person falling down or on the stair may cut or impale themselves.

The excessive pitch, inadequate guarding, lack of handrails and the wall/window configuration in conjunction with the restricted landing at the foot of the stair significantly increases the likelihood of a fall and the potential for serious injury should a fall occur.

The premises have been habitually used as a house in multiple occupation, but currently has only one occupant and her small child, has in the interim been requested not to introduce any more tenants. The stair is extremely dangerous to any person using it, regardless of their age due to its poor design, construction and the use of inappropriate materials.
