Example 8 – Food Safety

HHSRS V2 SCORING SHEET

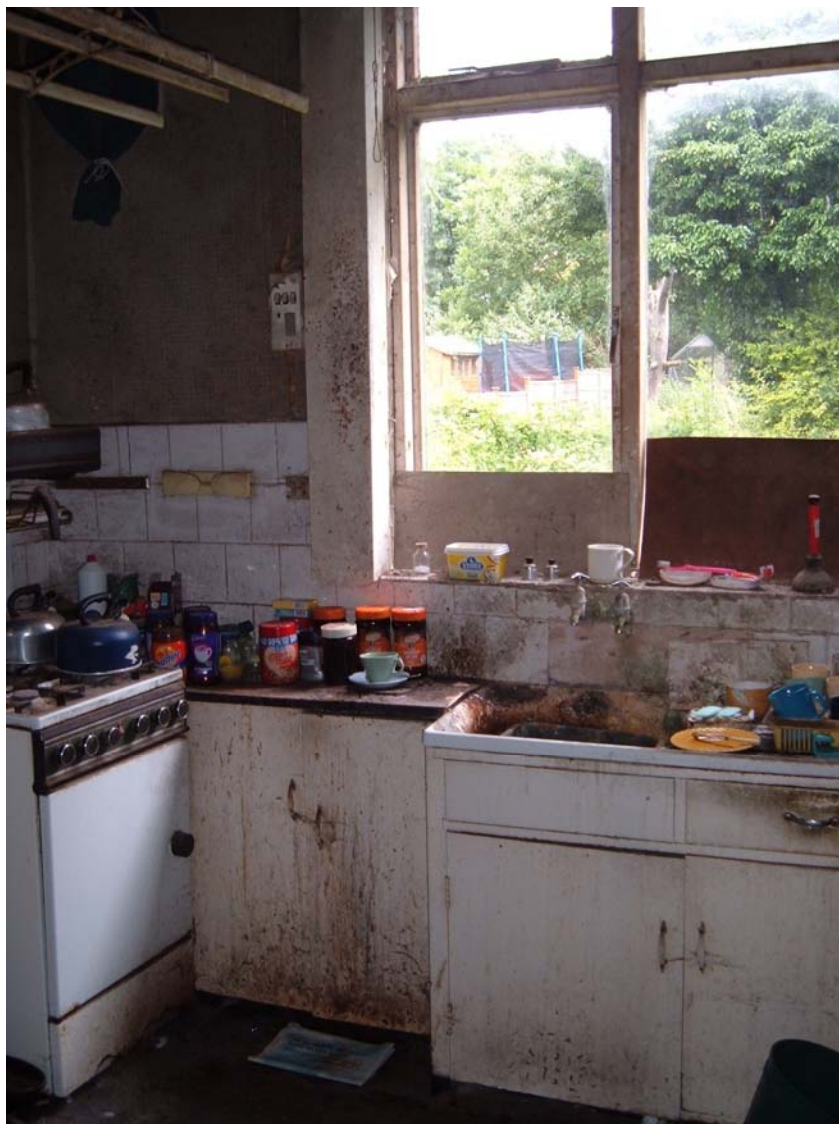
The kitchen contains very little worktop space, a poorly located cooker, defective sink and is generally not readily cleansable. There are no seals around the sink, leading to water leaking to the unit below. The kitchen is of a poor layout and provides little room for manoeuvre.

The group decided that they would take action on this issue. It was decided that an Improvement Notice would be served if no result was achieved from informal action
